# Streamflow Conditions in the Arkansas River Basin Water Year 2022

In cooperation with the Arkansas River Compact Administration

**Brandon Forbes**  
USGS Colorado Water Science Center  
December 8, 2022  
bforbes@usgs.gov

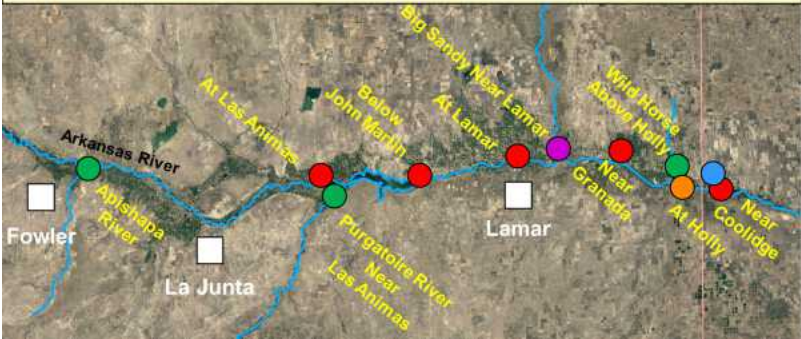
## USGS/ARCA Cooperative Streamgauge Program

- Mainstem Arkansas Sites (5)
- Tributary Sites (3)
- Frontier Ditch
- Potential Discontinued Site: Big Sandy nr Lamar
- Potential Reestablished Site: Arkansas River at Holly

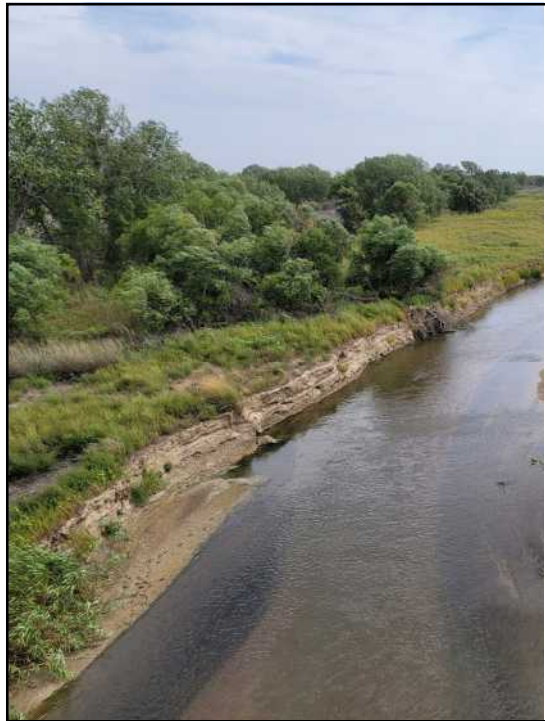
## Proposed Changes to the Engineering Committee

- Discontinuation of the Big Sandy Gage
- Reestablishment of the Ark River at Holly Gage
- Reuse gaging equipment to save costs
- Installation of new equipment
- 6 additional stream flow measurements to improve rating development

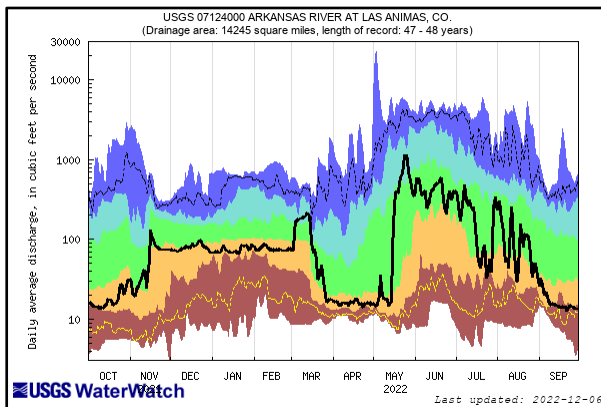
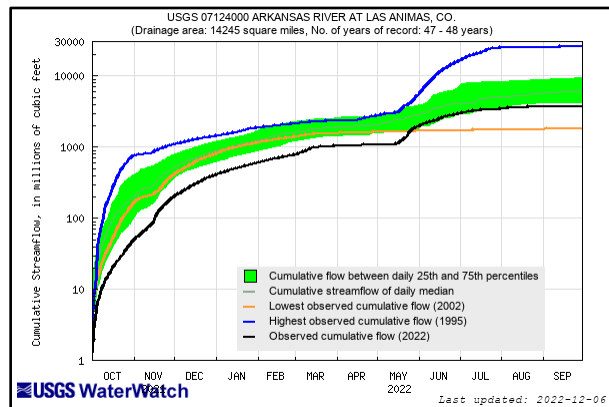
### Arkansas River at Las Animas

Explanation - Percentile classes						
lowest-10th percentile	5	10-24	25-75	76-90	95	90th percentile-highest
Much below Normal	Below normal	Normal	Above normal	Much above normal		Flow

In Water Year 2022:  
**88,746 Acre-Feet**, 47% of the long-term average

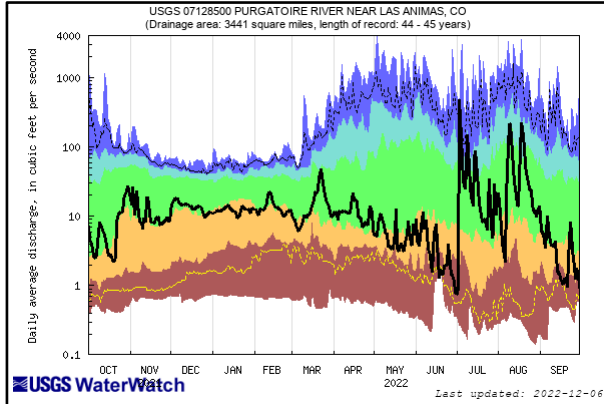
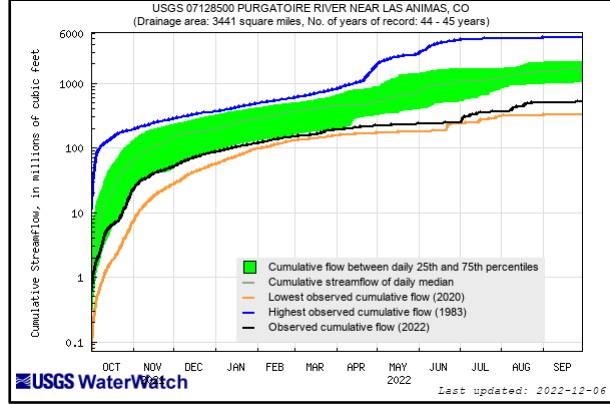
## Purgatoire River near Las Animas

Explanation - Percentile classes						
lowest-10th percentile	5	10-24	25-75	76-90	95	90th percentile-highest
Much below Normal	Below normal	Normal	Above normal	Much above normal		Flow

In Water Year 2022:  
12,145 Acre-Feet, 29% of the long-term average

-The two major tributaries to John Martin Reservoir, the Apishapa and the Purgatoire produced 32% and 29% respectively, of the long-term average flow.

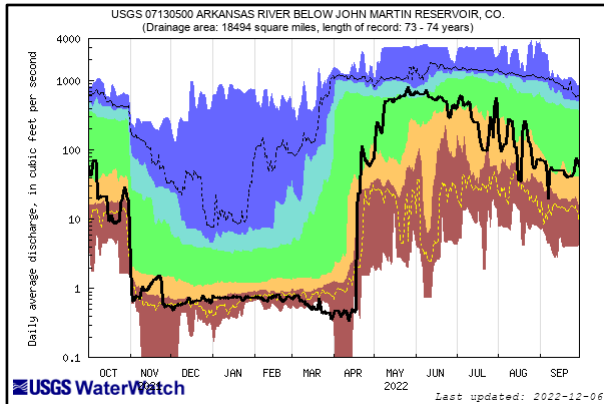
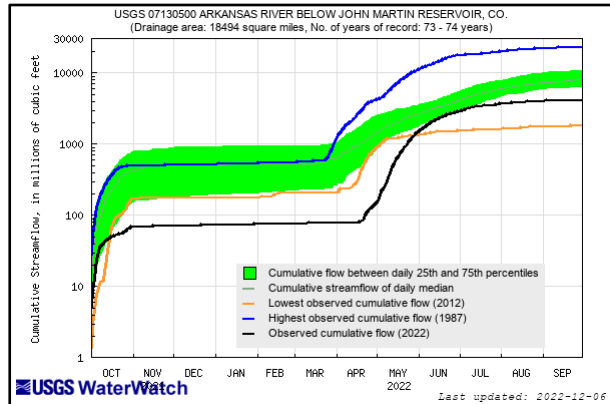
## Arkansas River Below John Martin Reservoir

Explanation - Percentile classes						
lowest-10th percentile	5	10-24	25-75	76-90	95	90th percentile-highest
Much below Normal	Below normal	Normal	Above normal	Much above normal		Flow

In Water Year 2022:  
98,156 Acre-Feet, 49% of the long-term average

-Outflow from John Martin Reservoir produced 49% of the long-term average.

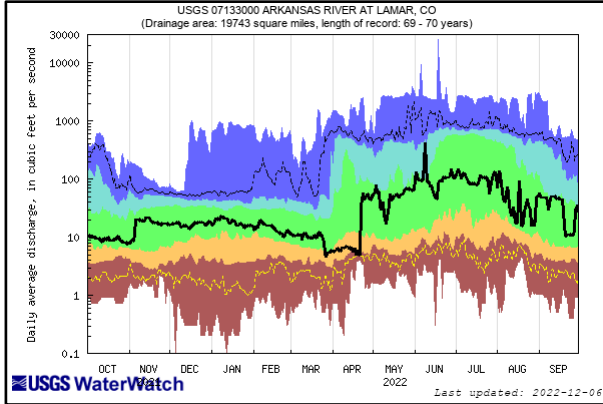
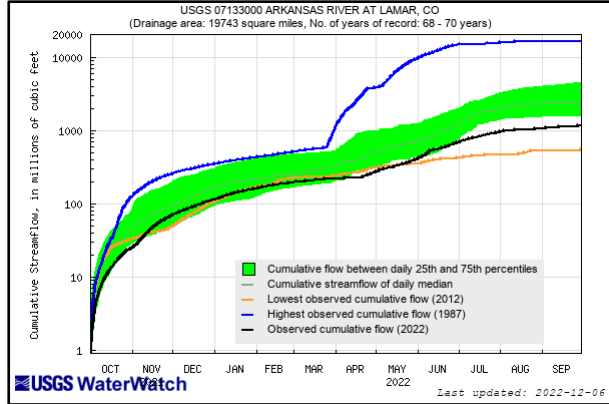
## Arkansas River at Lamar

Explanation - Percentile classes						
lowest-10th percentile	5	10-24	25-75	76-90	95	90th percentile-highest
Much below Normal	Below normal	Normal	Above normal	Much above normal		Flow

In Water Year 2022:  
27,118 Acre-Feet, 34% of the long-term average

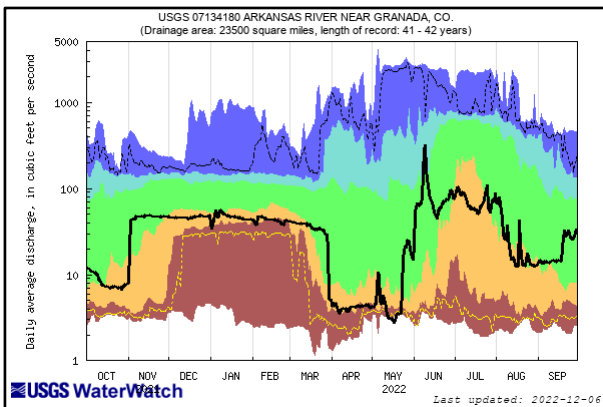
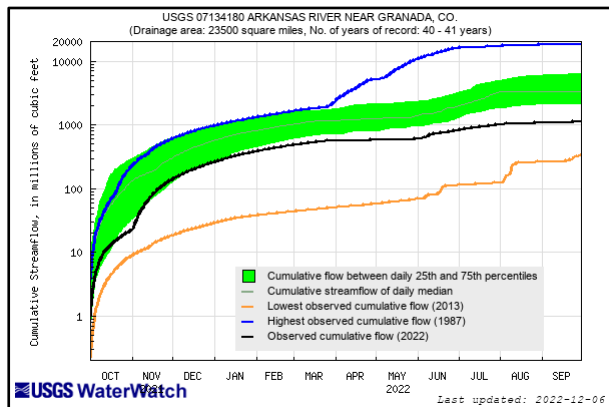
## Arkansas River at Granada

Explanation - Percentile classes						
lowest-10th percentile	5	10-24	25-75	76-90	95	90th percentile-highest
Much below Normal	Below normal	Normal	Above normal	Much above normal		Flow

In Water Year 2022:  
26,668 Acre-Feet, 23% of the long-term average

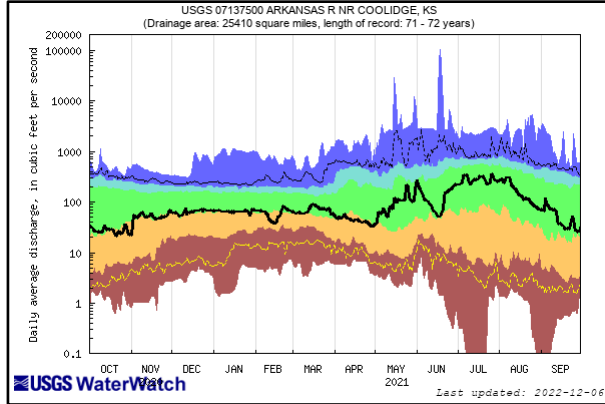
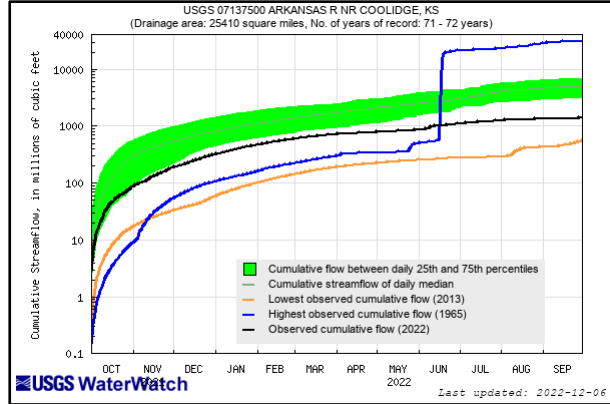
## Arkansas River at Coolidge

Explanation - Percentile classes						
lowest-10th percentile	5	10-24	25-75	76-90	95	90th percentile-highest
Much below Normal	Below normal	Normal	Above normal	Much above normal		Flow

In Water Year 2022:  
33,160 Acre-Feet, 23% of the long-term average
